**Motor Assessments
& Factual Investigators**

Re : xxxxxxxxxxxxxxxVs xxxxxxxxxxxxxxx

THE VEHICLE

Make	Volkswagen
Model	Beetle 1500
Year	1969
Body	2 Door
Vin	xxxxxxxxxxxx
Reg No	XXX 10T
Colour	Blue

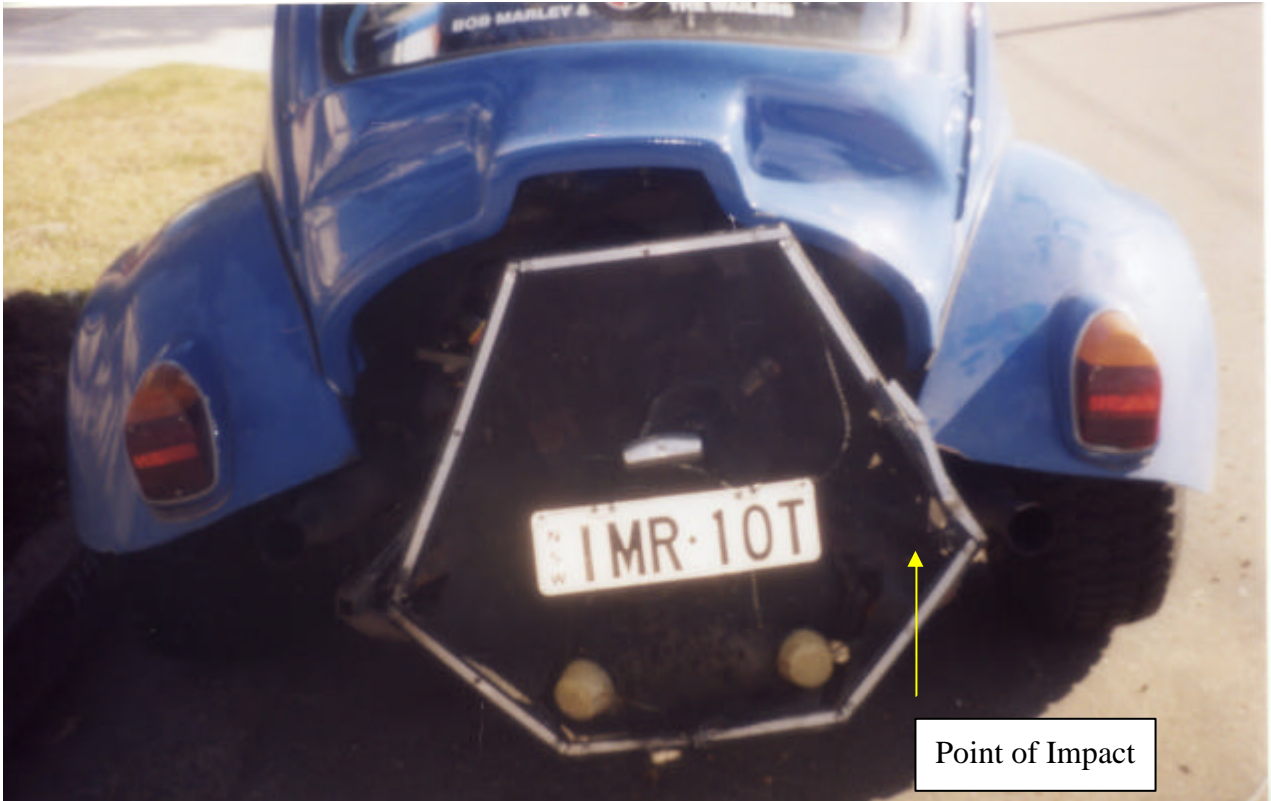
13. In this case this Volkswagen Reg No XXX 10T has had its rear end cut off and original panels removed and fitted with aftermarket fiberglass panels fitted poorly. They can be seen to be sagging from the rear. They should be supported by a bracket system.

14. The strengthening reinforcing bar work was never fitted exposing the engine leaving no protection. The flimsy fabricated grille did little apart from hold the reverse lights and number plate. I consider this to be an illegal component leaving no protect to any pedestrian passing by from sharp edges. If the correct bar was fitted much of this damage would never have occurred. Illustration of the bar work is at the rear of the report.

15. An engineer's certificate would need to be provided by the owner showing that this vehicle is legally acceptable and roadworthy to be on the roads and meeting Australian Design Specifications.

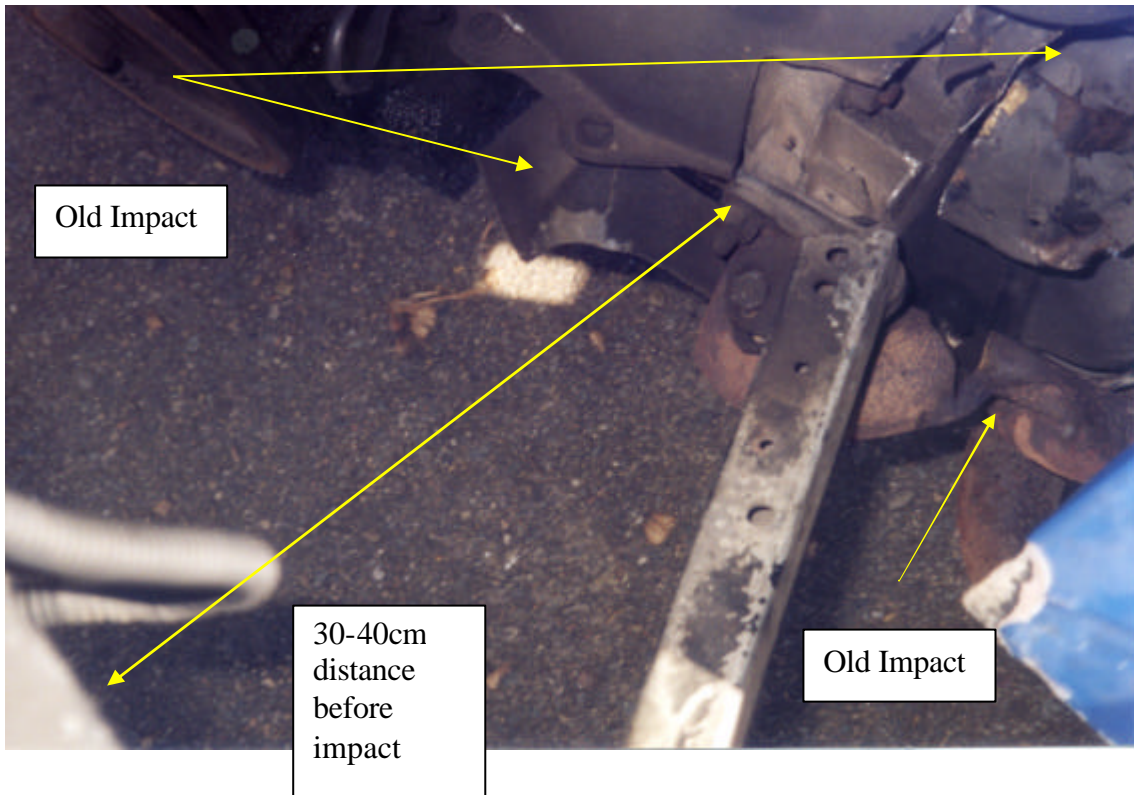
Right Side Engine

23. Items marked “not required old damage” I believe not to be consistent with this incident. Reasons for this is the aging dark colour of the rust on most of the damaged components.

24. The exhaust shows signs of a heavy impact which is not consistent as the distance between the damage area and the rear grille is 30-40cm and even of the left side is damaged. It has old aging dark rust on both sides. The split area shows a darkening effect showing that it has been leaking for some time.

27. The fresh scraps to the engine cover are from the brace for the rear grille flapping around from not being secured with a bolt. This is evident as when a bolt is tighten it leaves circular mark which can be seen in this case but dirt residue and road grime has settle over these marks indicating that there has been no bolt for some time.

25. I have considered \$100 to be adequate cost of repair to cover some welding to this damaged system.

26. The quoted price for the exhaust is for both sides. This exhaust is a two piece set up Left and Right. Only the right would have been needed.

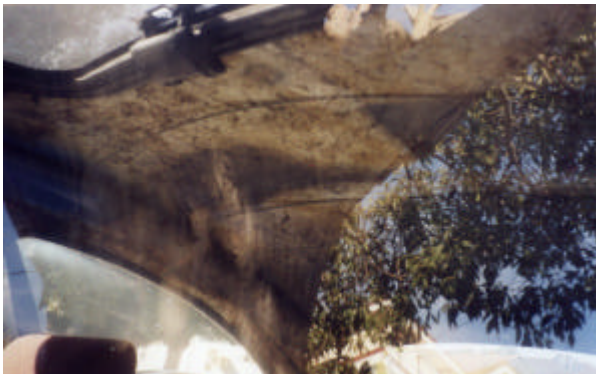
No Headlining

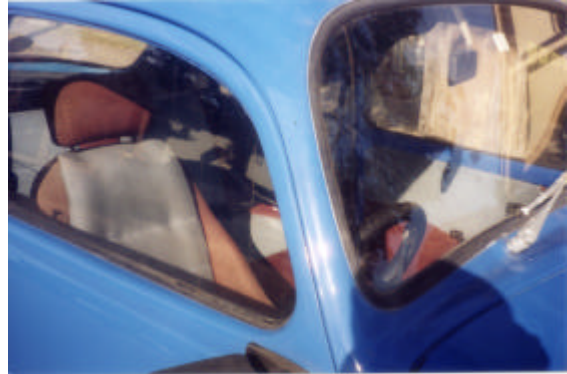
Only One seat fitted
